Revisiting the causes of the Hatfield Rail Crash

By Prof Roger Kemp MBE FREng

Executive summary: In October 2000, an InterCity 225 train derailed south of Hatfield station, resulting in four fatalities and more than 70 people injured. The official inquiry blamed failures of the maintenance contractor and poor supervision by the infrastructure manager. Viewing the accident as the outcome of a failure of a complex system suggests that much of the blame rested with the governance arrangements created by the privatisation of the rail network.

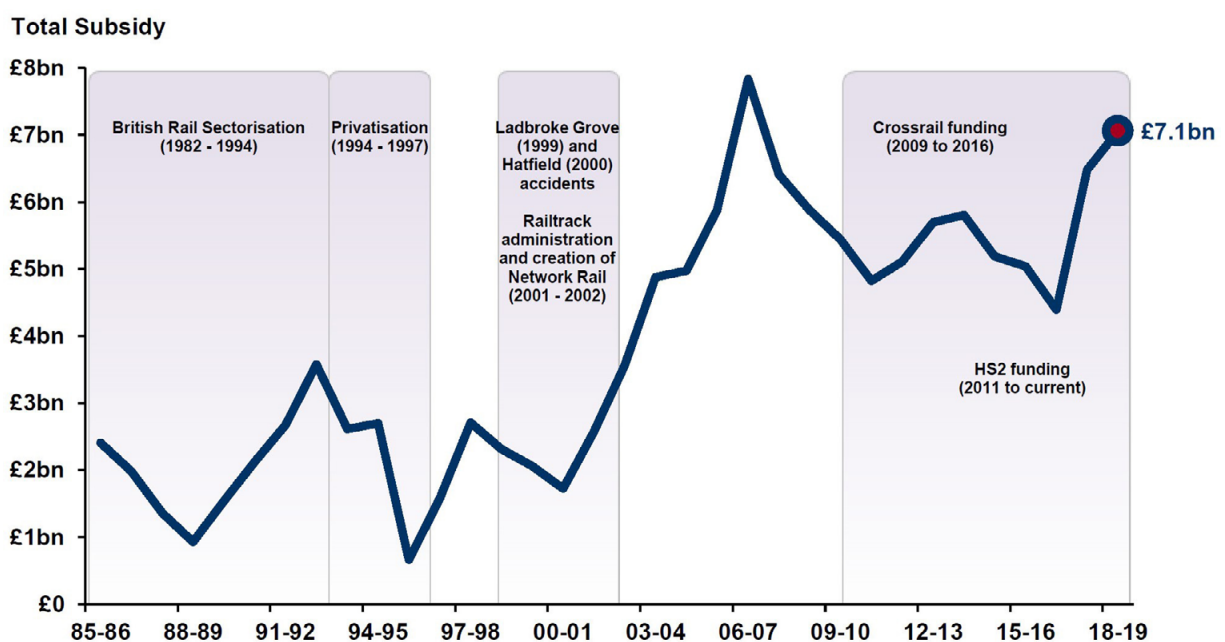
It should be noted that Network Rail, the successor of Railtrack, instigated a more intensive rail replacement, reballasting and rail grinding programme than either British Rail or Railtrack had achieved – but this required significant capital investment in plant and machinery and a 200% increase in subsidy. This is shown in **Figure 1**, taken from a 2018 government report.⁷

Figure 1: Subsidy to rail industry at 2018 prices.

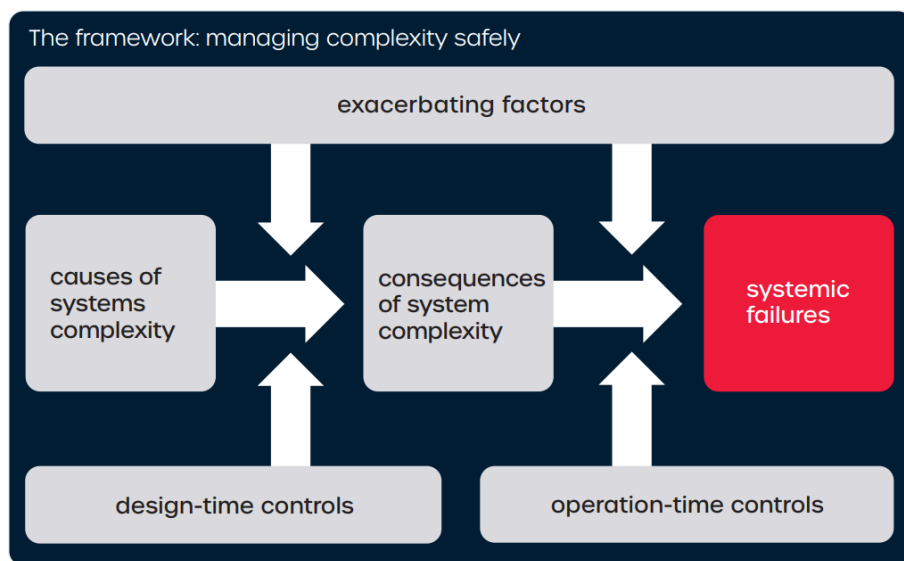
The introduction refers to a report by York University,¹⁴ which describes a model for the evolution of systemic failures in complex systems, shown in **Figure 2**. The report identified two main processes for reducing the risk: design-time controls and operation-time controls.

When analysing the Hatfield crash, it appears that the York model is lacking a stage – the specification. Before there can be design-time controls, the design team needs to know there is a risk that has to be managed. In the procurement of the I225 trains, RCF was not identified by British Rail as an issue that train designers needed to be involved with. In the frenetic activity to start work on a project that was won on the basis of a best and final competitive bid with a two-year delivery time and stringent penalties, there were no prizes for diverting design effort onto a list of difficult issues that were not in the specification.

Figure 2: Sources of systemic failures.

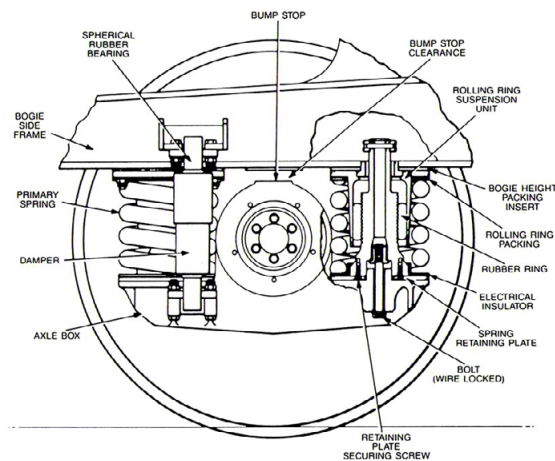
The Class 91 primary suspension system (between the wheelsets and the bogie frame), shown in **Figure 3**, used coil springs to provide vertical stiffness and rolling rubber ring units to give the necessary lateral and longitudinal restraint.

The means of primary longitudinal restraint is important in understanding the causes of RCF. When a train goes round a curve, the wheelsets attempt to align radially – that is to say the axles point towards the centre of the curve. If the longitudinal suspension is too stiff, the axles remain almost parallel and impose significant longitudinal forces on the rail at the contact with the wheel.

Figure 3: Class 91 primary suspension.

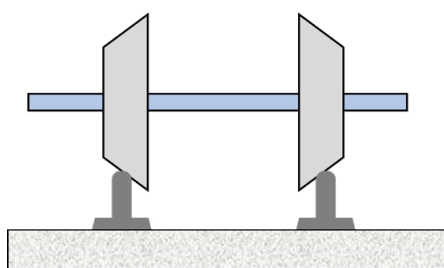
The wheel treads are to a first approximation, conical. On straight track, the wheels are central on the track, as shown. On a curve, the wheelset (the pair of wheels and the axle) moves outwards, away from the centre of the curve, so the outer wheel runs on a larger diameter and the inner wheel on a smaller diameter. Obviously, this only works on relatively gentle curves – on sharper curves the wheelset moves to the end of the conical section where there is a flange to prevent it moving further. It is usual to provide flange lubricators, either on the train or the trackside, that apply grease to the flange to prevent excessive wear.

The greater the conicity, the sharper the curve that can be traversed without flange contact and also the greater the centring force applied to the wheelset on straight track. If the centring force is too great and changes too rapidly for a small displacement, the bogie can ‘hunt’ (oscillate around its central pivot), noticeable by violent shuddering in the passenger vehicle. As a wheel wears, the effective conicity changes.

One of the factors driving up conicity on the Railtrack network was the insistence by infrastructure managers that they should be able to minimise rail replacement costs by transposing left and right rails. If the inside edge of each rail has worn down, by transposing them, the lightly-worn outside edge can be used. Unfortunately, contact between

Figure 4: Illustration of conicity.

the sharp corner of the rail and the wheel profile created a very high effective conicity. Inevitably, this required high levels of damping in the suspension components. The Class 91 locomotive involved in the Hatfield crash was specified for wheel-rail conicities up to 0.4. In comparison, the French TGV-PSE, its near contemporary, was optimised for a 0.05 conical wheel profile, although it was stable at higher levels.

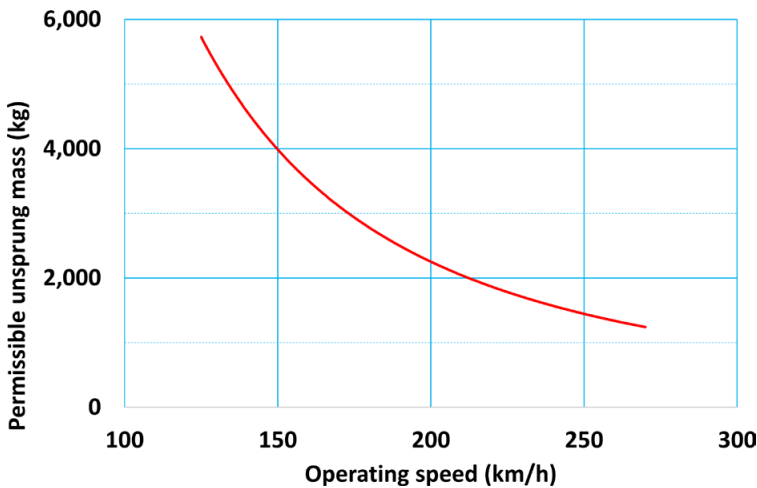
seen as a problem – a pragmatic comparison of which locomotive types caused track damage (the 160 km/h electric Class 86, with 5 tonne unsprung mass) and which didn’t the 160 km/h diesel-powered Deltic locomotives, with a 3.3 tonne unsprung mass). This resulted in the Deltic Criterion against which designs were assessed (**Figure 5**).

Figure 5: The Deltic criterion.

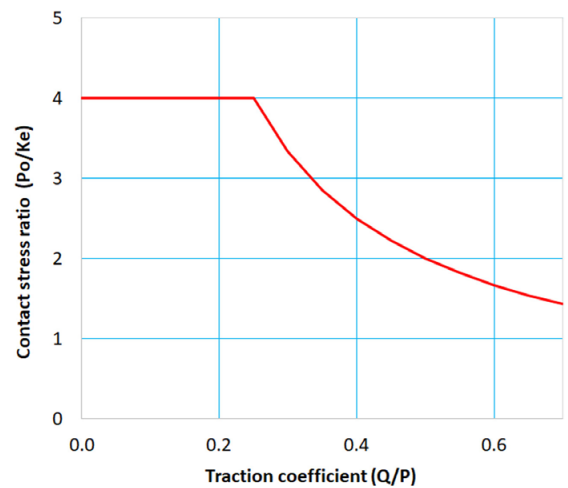
To avoid flange wear, railways apply lubricant to the flanges on the approach to curves. This can be by ‘greasers’ mounted on the sleepers that apply grease to passing wheel flanges or high-pressure lubricant sprays mounted on the bogie or stick lubricators (looking like oversize lipsticks) that bear on the wheel flanges. The British Rail privatisation raised several questions about responsibility for maintaining adequate flange lubrication – was it the train operator or the infrastructure owner? Too little lubrication results in flange wear and, in extremis, flange climbing and derailment; too much can contaminate the rail surface and extend braking distances, resulting in signals passed at danger (SPADs) and, potentially, accidents. Following the accident, it emerged that a large proportion of flange lubricators were not working, thus increasing the traction coefficient (see **Figure 6**).

A 1991 paper by Cambridge academics²⁴ provided a summary diagram of the factors that contribute to rolling contact fatigue in railway rails (**Figure 6** is a simplified version). While the

Figure 6: Susceptibility of rails to RCF.

operating point is in the elastic region, the rail surface flexes, but goes back to normal; if it is in one of the flow regions, it distorts permanently and, over time, can crack.
